# Inspection Report

8800 SW Garth  
Seattle WA

Cardinal Home Inspection  
9216 Fourth Ave SW  
Seattle, WA 98106

110214A

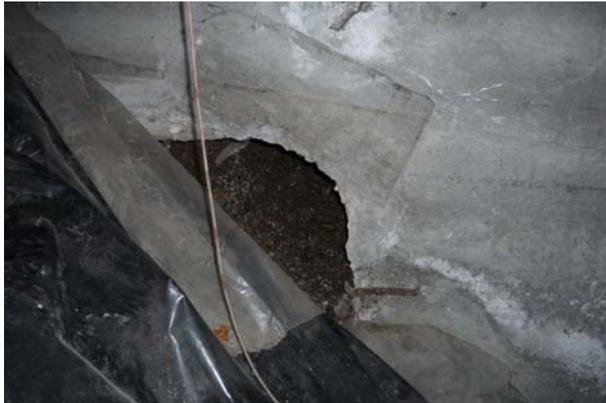
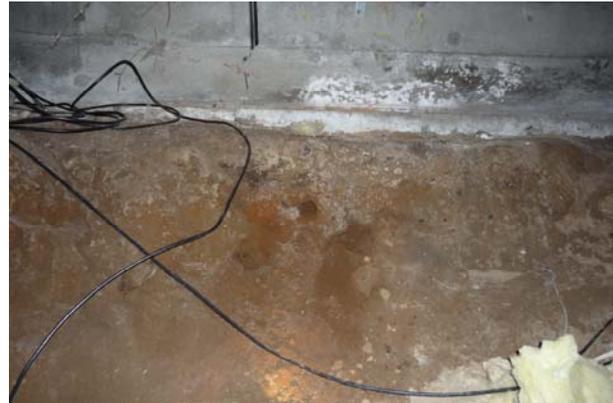
**1. Major Concern :->** Parts of the foundation footing system are undermined and require improved support so that the foundation has adequate bearing onto un-compacted soils. Also, the soil has been dug away from the south foundation wall and a retaining wall needs to be engineered to support the soil next to the wall. Hire a structural engineer or licensed general contractor familiar with foundation repair to further evaluate this condition and repair as needed.

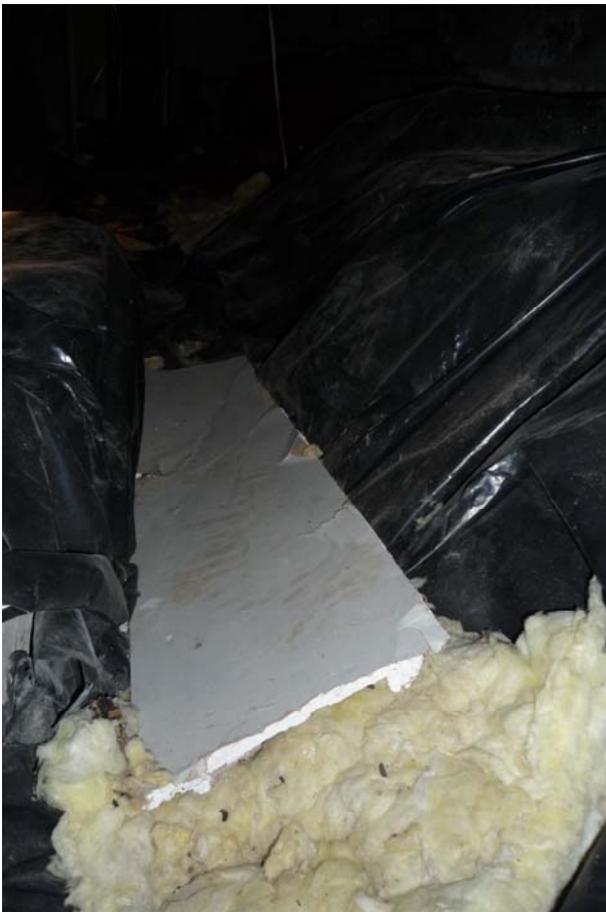
**3. Repair** :-> Wood and construction debris was noted in the crawl space. This can encourage pest and rot conditions in the home. Removal of all cellulose debris from the crawl space is recommended to eliminate conducive pest conditions.

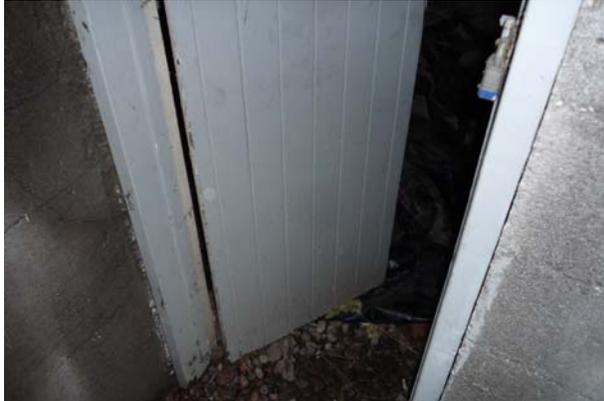
**4. Repair :->** The crawl space access hatch does not look rodent proof. Rebuilding is recommended to eliminate a rodent entry point.

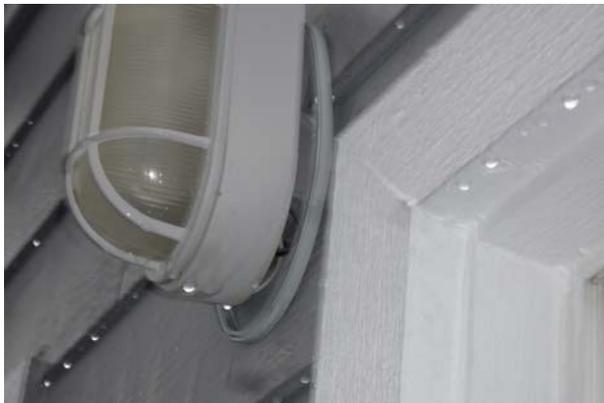
**12. Repair ->** Secure the loose deck fixture.

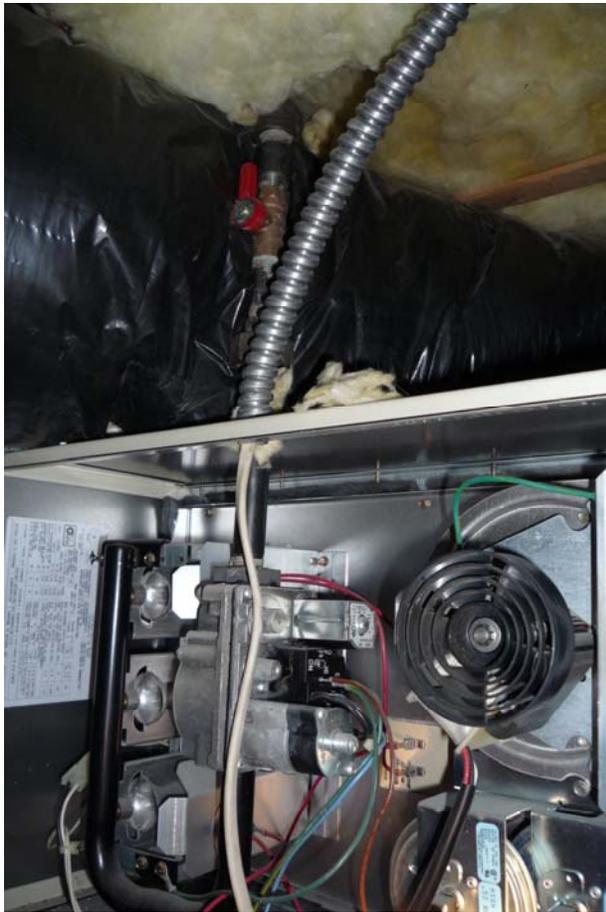
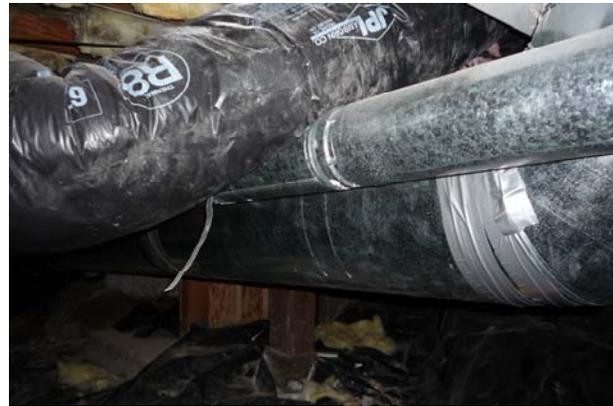
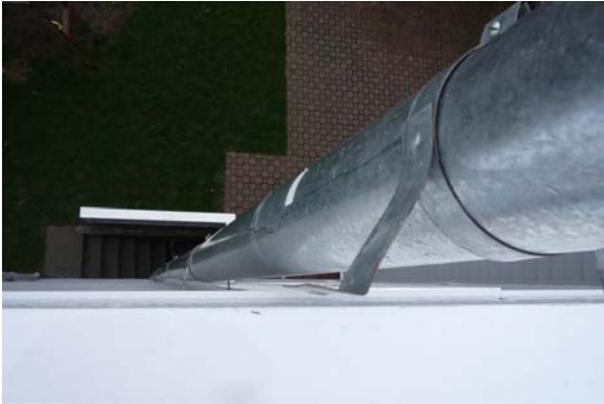
**14. Major Concern :->** This furnace was not installed according to manufacturer's installation instructions. The venting has too long of a horizontal run and does not slope upward at 1/4 inch per foot. The gas line lacks a drip leg. The furnace is not properly supported. The vent line comes into direct contact with the ducting. The vent is not supported properly outside for the top ten feet. Replace the furnace with a direct vent furnace installed by a licensed heating contractor.

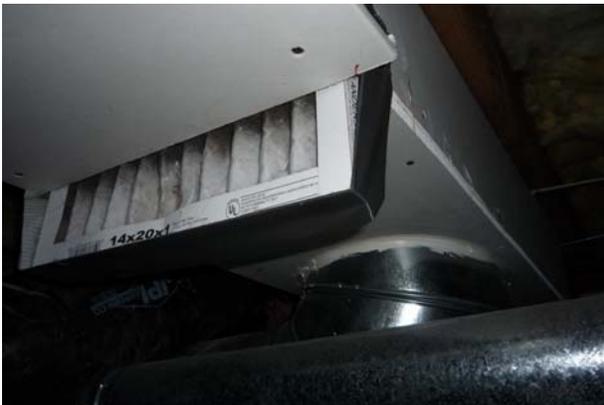
**15. Repair :->** The furnace filter access lacks a cover. This is an unsafe condition will draw crawl space air into the ducting system and significantly lower the efficiency of the heating system. Hire a qualified HVAC contractor to further evaluate and install a cover on the filter access.

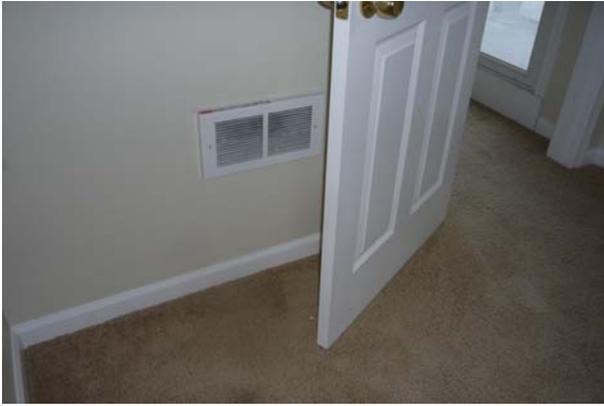
**17. Repair :->** The wall heater in the top south bedroom has the thermostat directly above it, which will cause the thermostat to shut off too soon. Move the thermostat. The heater in the top north bedroom is behind a door which is not allowable. Move the heater.

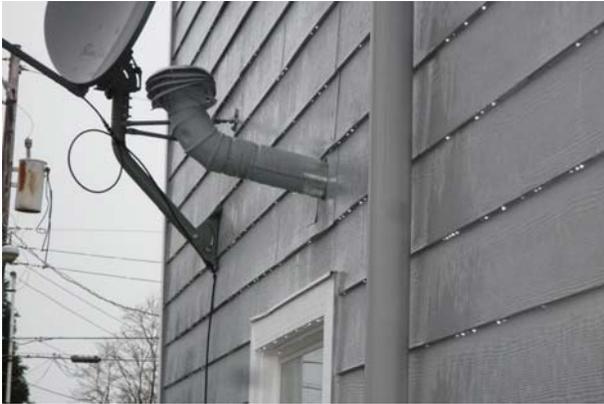
**22. Repair :->** The water heater is not properly vented. This type of water heater needs to be vented above the roofline. Replace the furnace with a direct vent appliance.

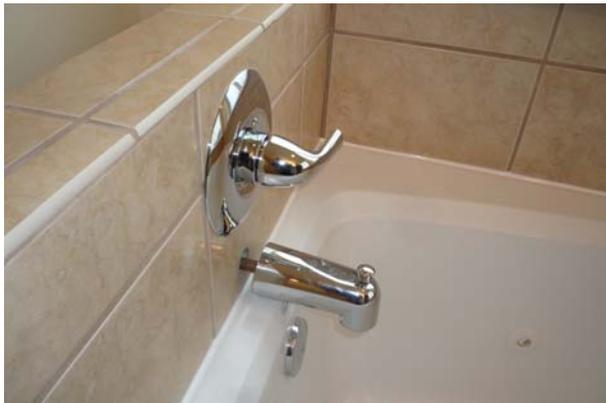
**26. Repair** :-> No access has been provided for the pump to the jetted tub. Access is required to inspect, service and repair this pump. The jets are not working and access will be needed to repair. Also, the tub spicket is not attached to the wall and the drain stopper is missing. Install proper access and otherwise repair.

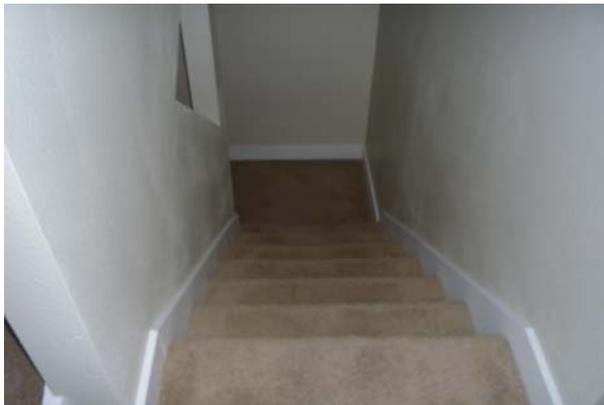
**31. Repair** => A graspable handrail is needed for the stairs for safety. All hand rails should extend the length of the stairs and have returns that terminate into the wall. Hire a qualified general contractor to further evaluate and repair.

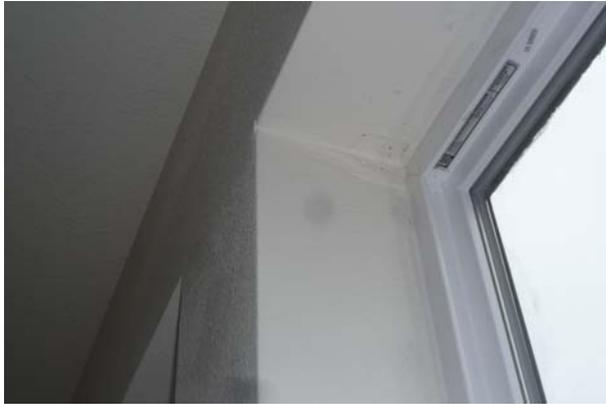
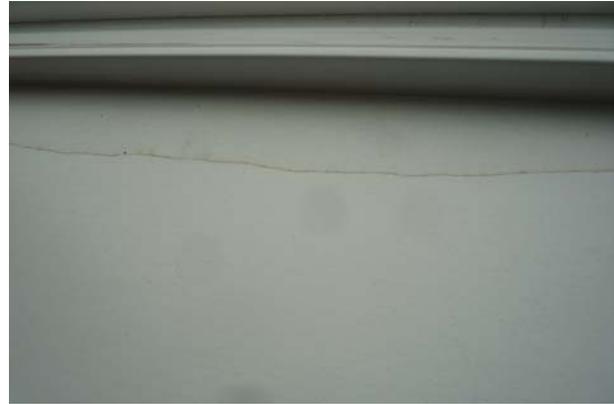
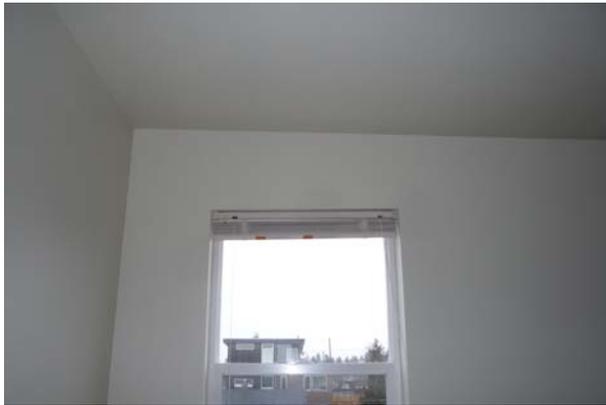
**32. Major Concern** => The windows are a hodge podge of poor installation practices and are vulnerable to leakage into the house and walls. At least one south face second floor window shows evidence of active leakage. Contact a licensed general contractor for further evaluation. Expect extensive repairs to make the building envelope water tight.

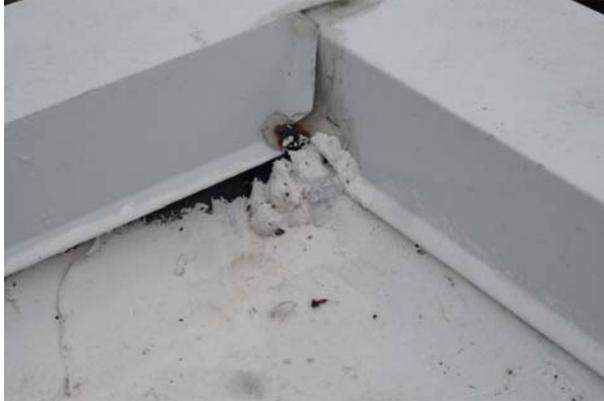
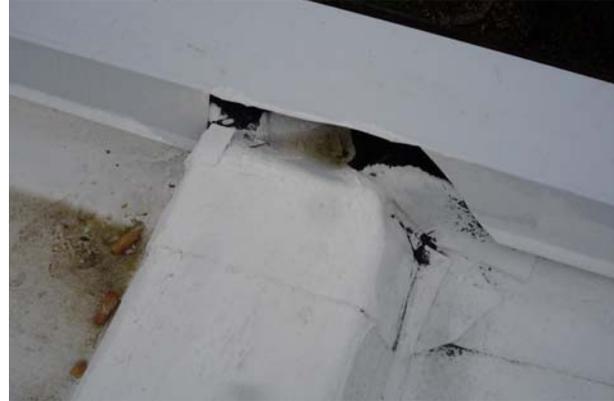
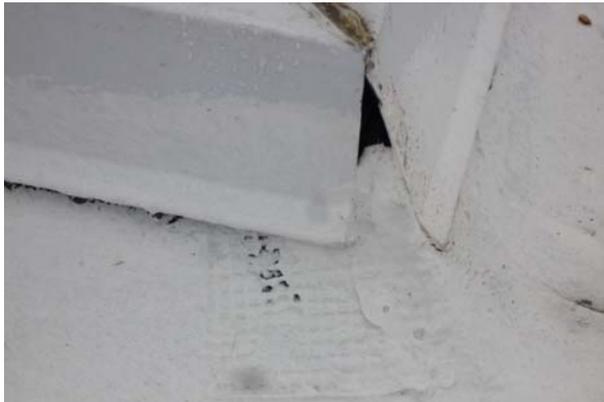
**34. Major Concern :->** The roofing membrane does not wrap around the cap and the cap flashing is poorly installed, making the exterior walls vulnerable to leakage. The scupper holes are poorly executed. Contact a licensed roofing contractor for repairs.

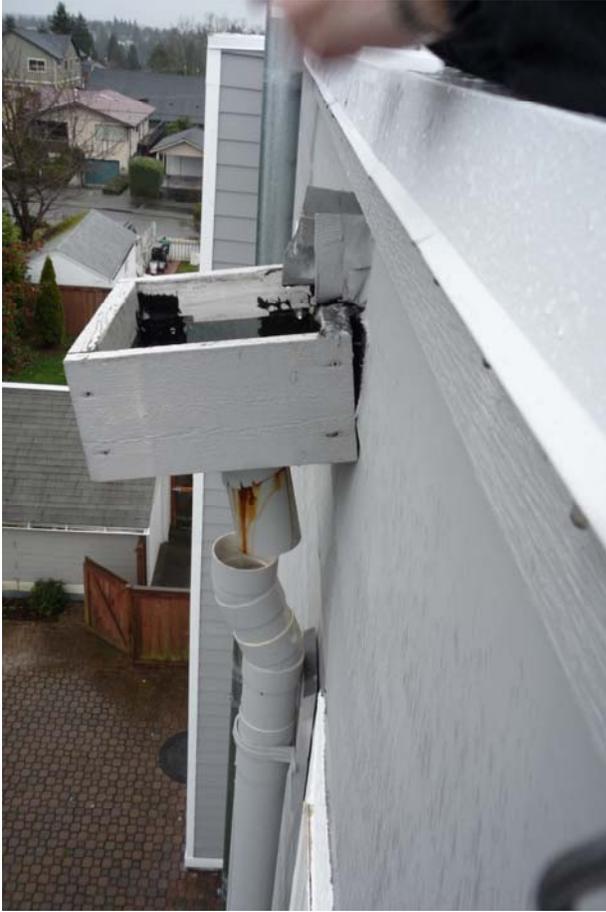
**35. Repair :->** The scupper drains are improvised wood boxes filled with tar. This is not a durable design. Metal boxes are made for this purpose. The scupper on the back of the house is balling off, and is not properly connected to the building. Contact a licensed roofing contractor for repairs.

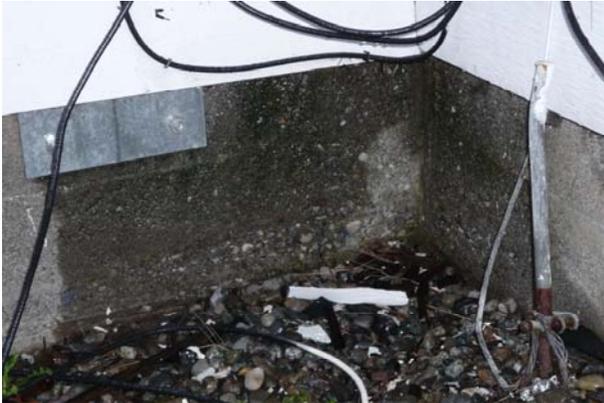
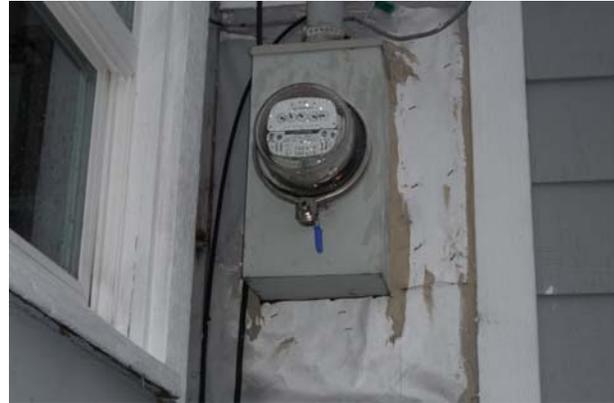
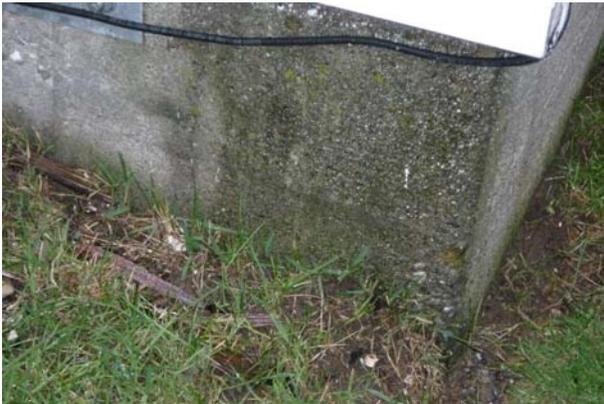
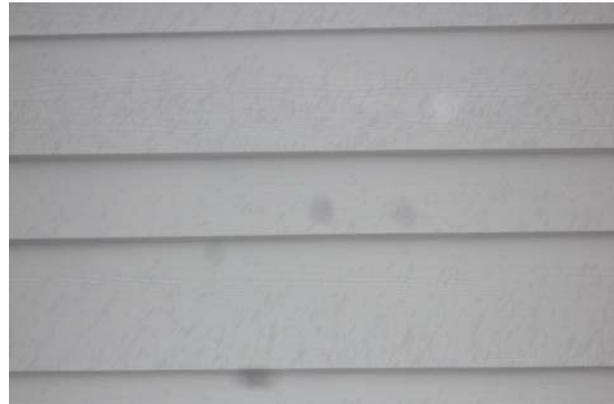
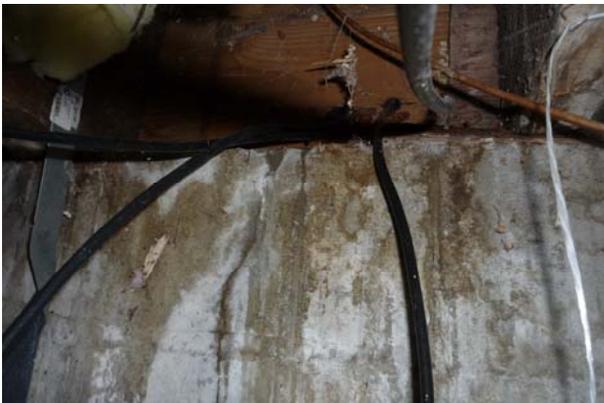
**36. Major Concern, WDO :->** The house has a serious building envelope failure due to poor installation technique at the roof, windows, deck and siding. Water appears to be leaking down on the back side of the siding in multiple areas and was not installed with consistent or proper reveal. Contact a building envelope specialist for a complete analysis of the leakage issues. There is likely hidden damage in the walls including mold.

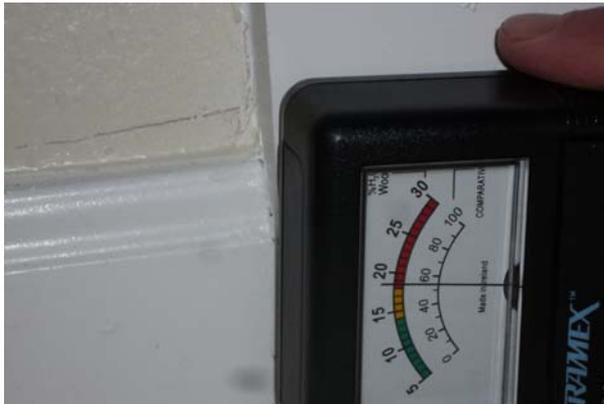
**38. Repair :->** The sliding glass door on the top floor is poorly installed. The wood beneath the door on the inside shows a high moisture reading indicating active leakage.

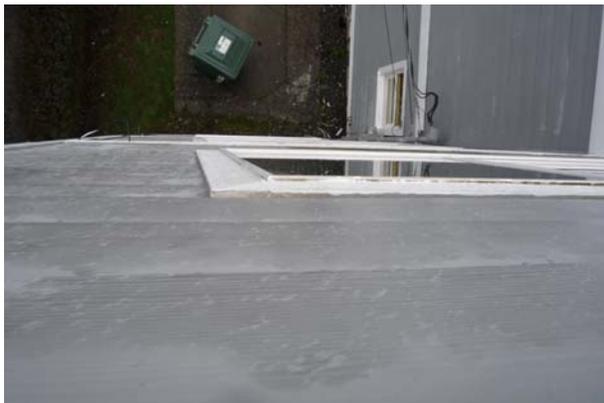
**39. Repair :->** Inadequate flashings were noted for the horizontal trim above the windows as well as band boards. This can lead to hidden water entry and damage, especially to those windows that are most exposed to the weather. Hire a licensed general contractor to further evaluate and repair.

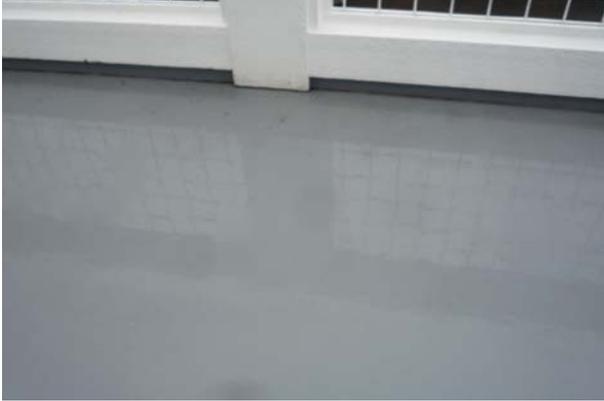
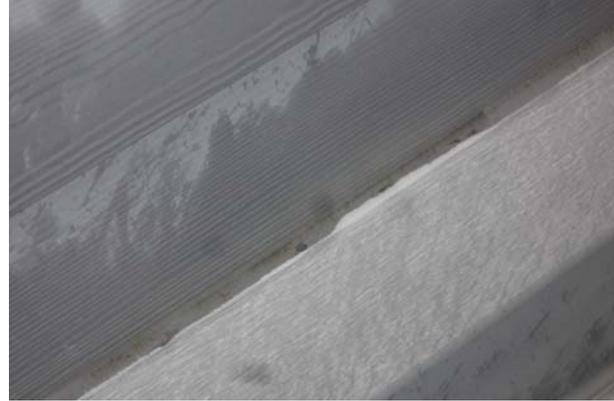
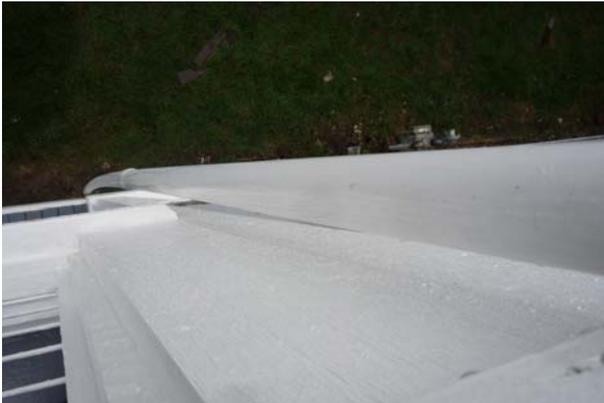
**40. Major Concern, WDO** :-> The decks have ponding along the rail edge because they do not slope fully to drain. This raises the likelihood of leakage under the deck. There is evidence that the lower deck is leaking to the lid of the front porch. The deck drain lacks proper support.

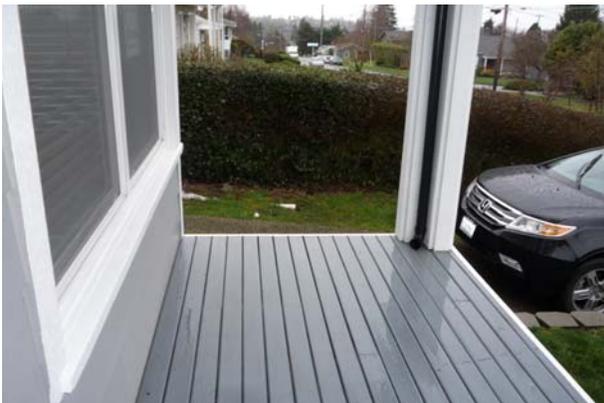
**41. Repair** :-> The front porch requires guardrails for all areas over 30 inches off the ground. The deck drains terminating on the porch will lead to rot in the framing in that area.

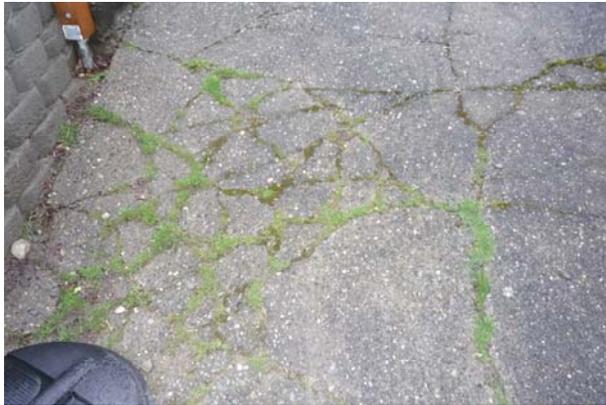
**42. Repair ->** Typical cracks were noted in driveway flatwork. This is a cosmetic defect. No immediate repair appears necessary, though water will continue to deteriorate the surface until the driveway is repaired or replaced.

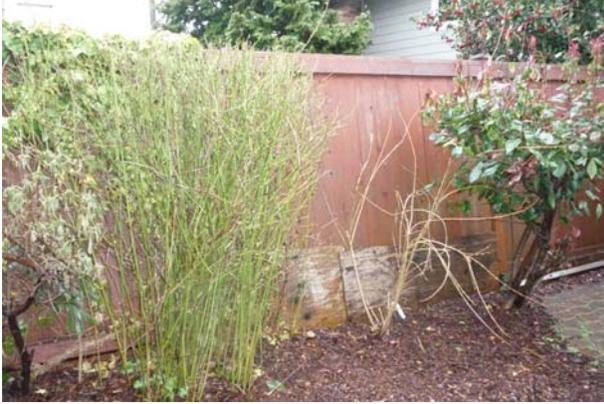
**44. Repair, WDO** :-> Localized areas of rot and loose and damaged fencing were noted. This is characteristic of older fencing. Updating the fence is recommended to repair the fence and eliminate conducive pest conditions.
